Manhole Inspection Summary

Manhole # S19W__003MH

Insp Date: **6/27/08 9:26 AM**

Location Address: **2345 somerworth st**

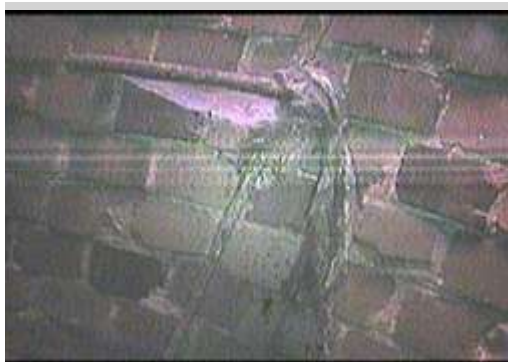
Defect 7

☒ **Evidence Of Surcharge** Depth: **5** (ft.) ☐ Active Surcharge Present

surcharge evidence

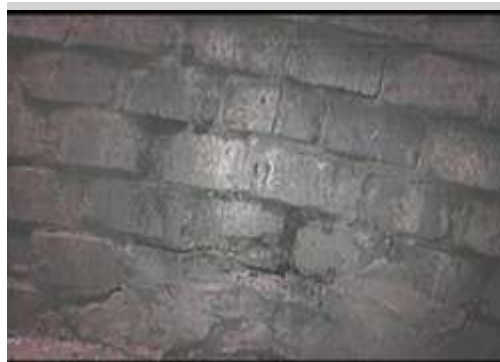
Defect 6

Infiltration: ☐ None ☐ Joint ☐ Cracks ☐ Mortar ☐ Roots ☒ **Wall**

infiltration @ barrel wall

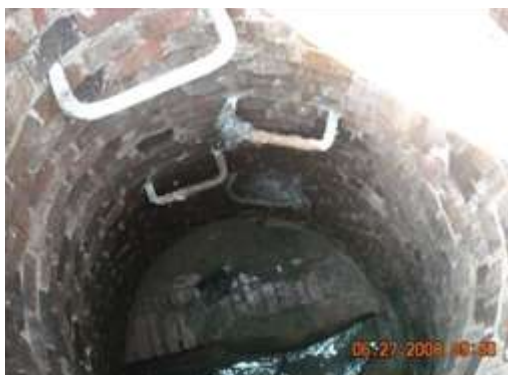
Defect 5

Count: **4** Missing: **0** ☒ **Corroded**

corroded steps

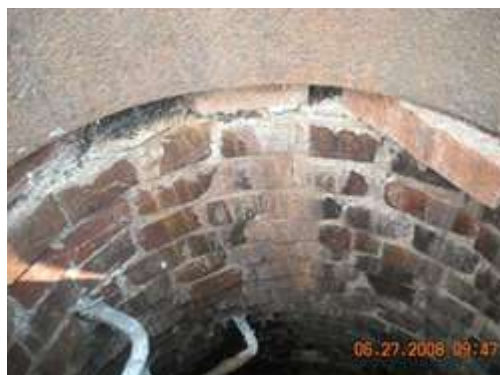
Defect 4

Infiltration: ☐ None ☒ **Joint** ☐ Cracks ☐ Mortar ☐ Roots ☐ Wall

infiltration @ chimney/frame joint

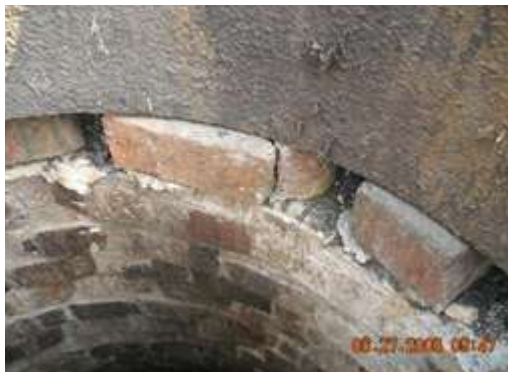
Defect 3

Condition: ☐ Sound ☒ **Cracked** ☐ Root Intrusion ☒ **Loose Brick** ☐ Deteriorated

cracked chimney brick

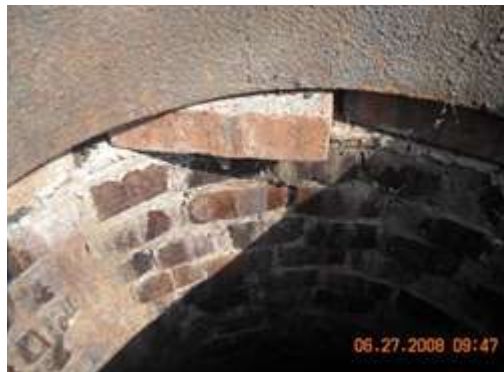
Defect 2

loose chimney brick

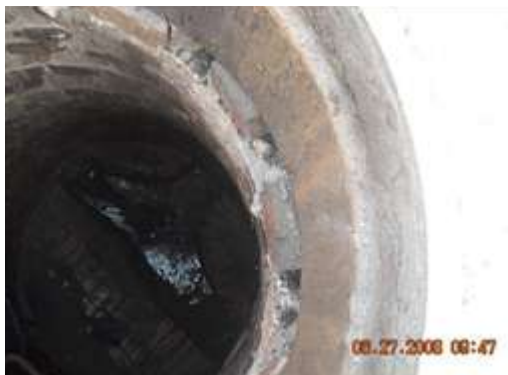
Defect 1

Offset: **1** (in.)

frame offset

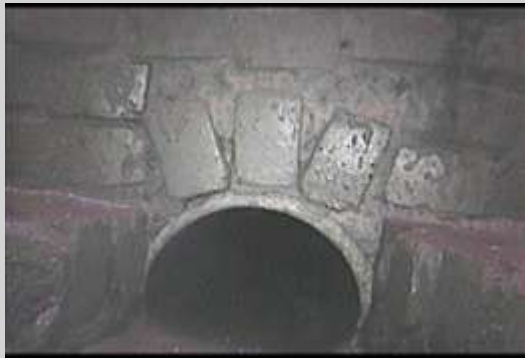
12 O'Clock Outflow

Pipe Height: **8.4** (in.) Rod and Bar (Angled)
Pipe Material: **Clay** ☐ Pipe Lined
Invert Depth: **8.45** (ft.) Flow Characteristics: **Fast**
Deposits: ☒ None ☐ Mud ☐ Sludge ☐ Debris ☐ Grease
Silt Depth: **0** (in.) Deposits Extent:
Infiltration: **None** Pipe Seal Cond: **Sound**

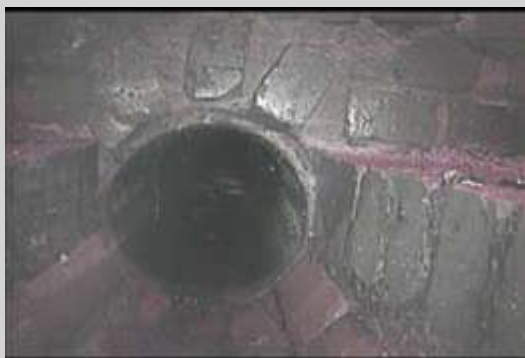
3 O'Clock Inflow

Pipe Height: **8.4** (in.) Rod and Bar (Angled)
Pipe Material: **Clay** ☐ Pipe Lined
Invert Depth: **8.22** (ft.) Flow Characteristics: **Slow**
Deposits: ☒ None ☐ Mud ☐ Sludge ☐ Debris ☐ Grease
Silt Depth: **0** (in.) Deposits Extent:
Infiltration: **None** Pipe Seal Cond: **Sound**

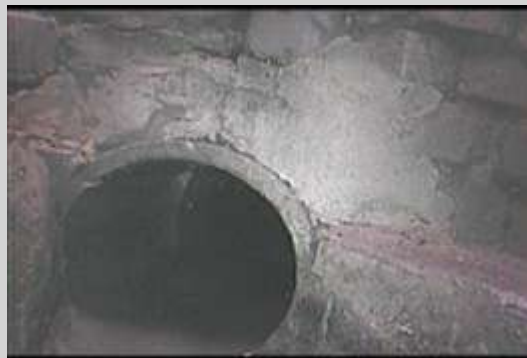
9 O'Clock Inflow

Invert Depth: **8.14** (ft.) Flow Characteristics: **Fast**

Infiltration: **None** Pipe Seal Cond: **Sound**
